## BEESSLACK, PENICUIK

### GROUND INVESTIGATION REPORT INCORPORATING COAL MINING RISK ASSESSMENT (CMRA)

STATUS	REVISION B
DATE OF ISSUE	OCTOBER 2024

Our Ref: WG684-45/MAK/ARB/KM

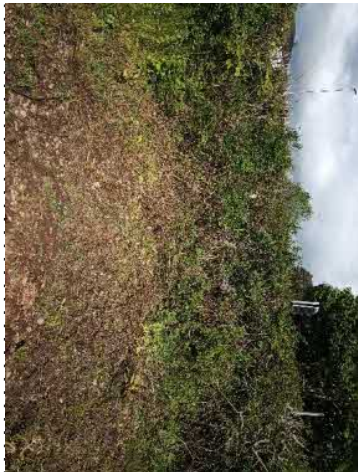
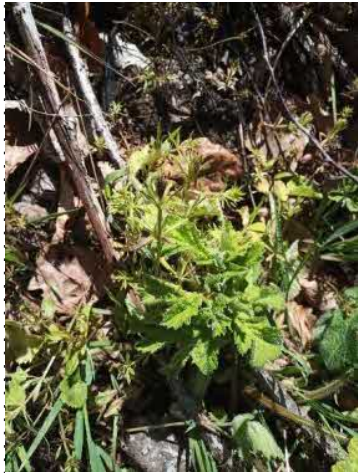
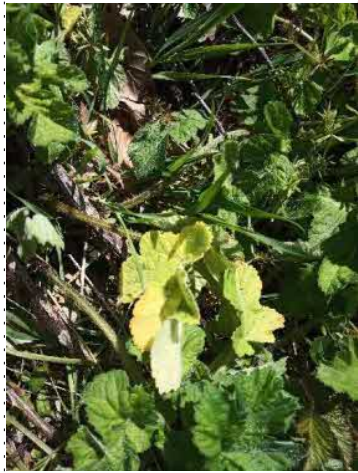
GH1 Giant Hogweed

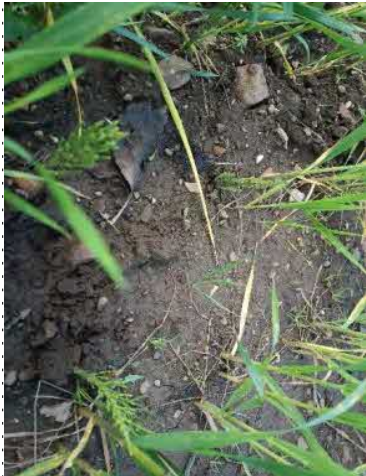
HT1 Horsetail

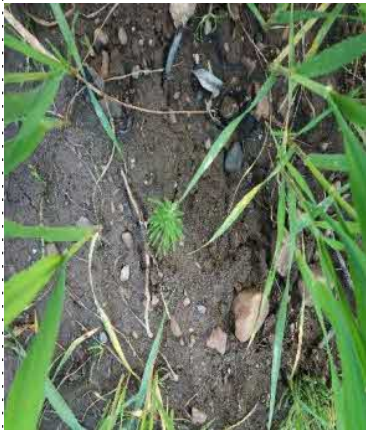
HT2 Horsetail

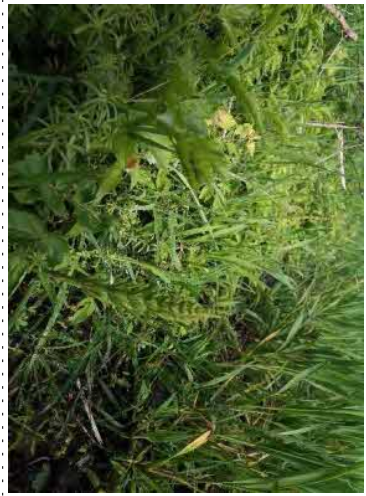
HT3 Horsetail
